④ **WINDY KNOLL LAKE DAM**
⑤ **WARREN COUNTY, MISSOURI**
MO 30512

⑥ **PHASE 1 INSPECTION REPORT**
NATIONAL DAM SAFETY PROGRAM

WINDY KNOLL LAKE DAM
MISSOURI INVENTORY NO. 30512
WARREN COUNTY, MISSOURI

Date of Inspection: 9 June 1980

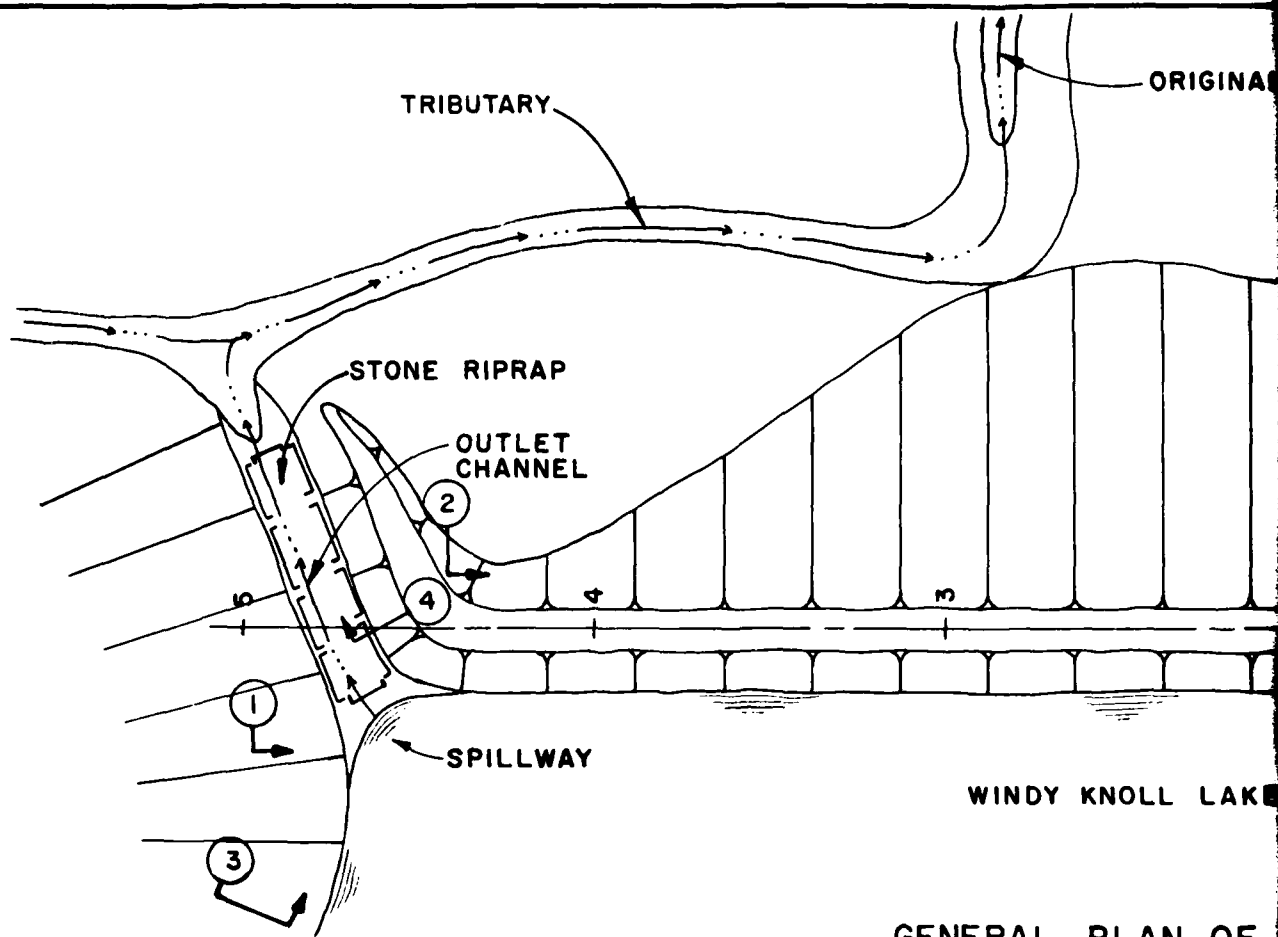
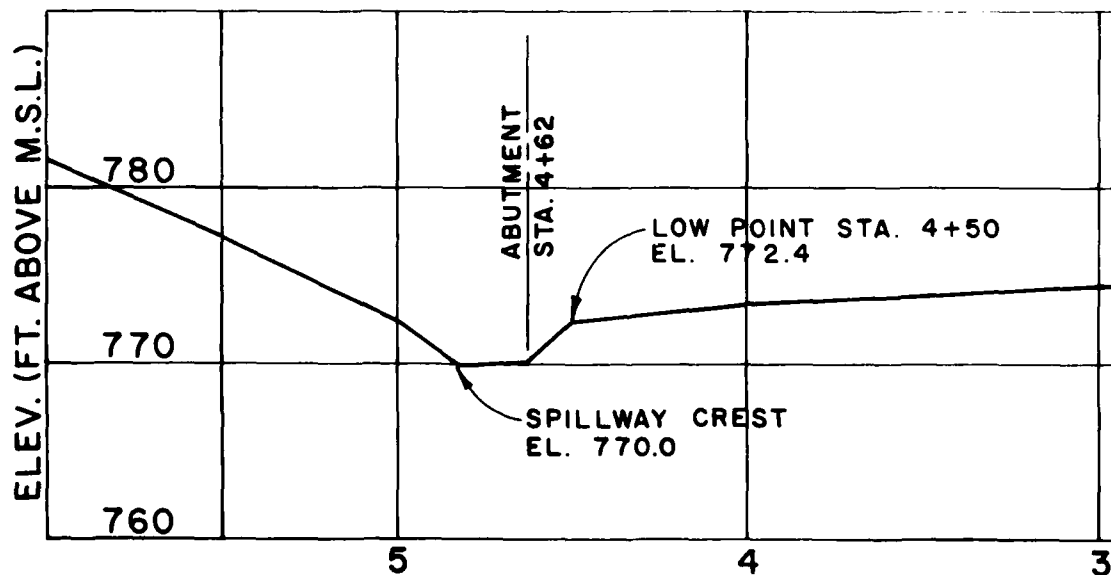
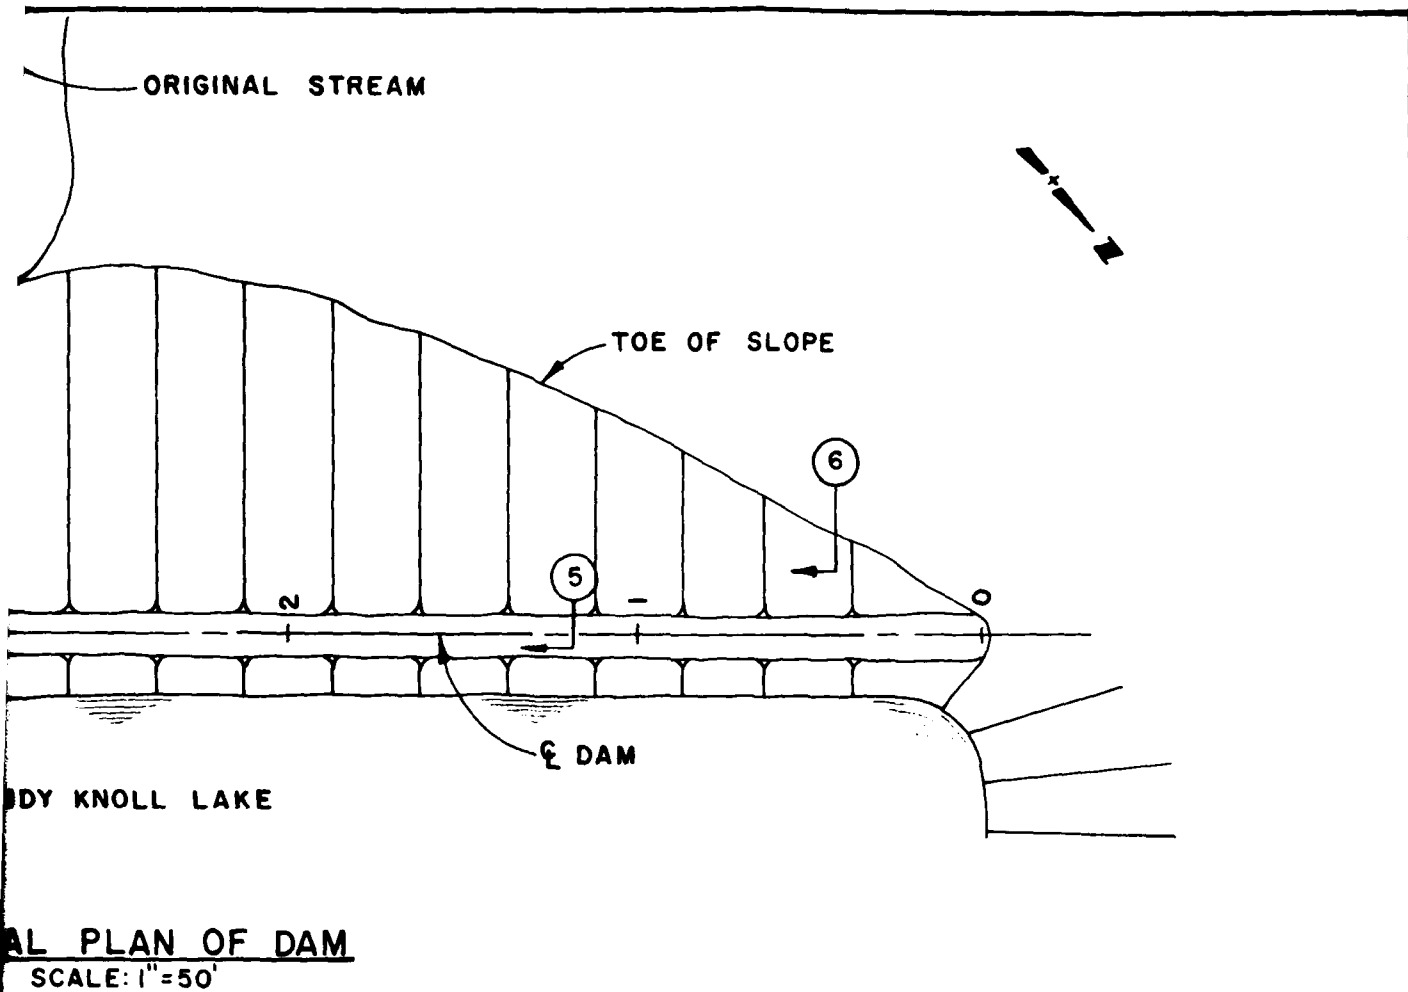
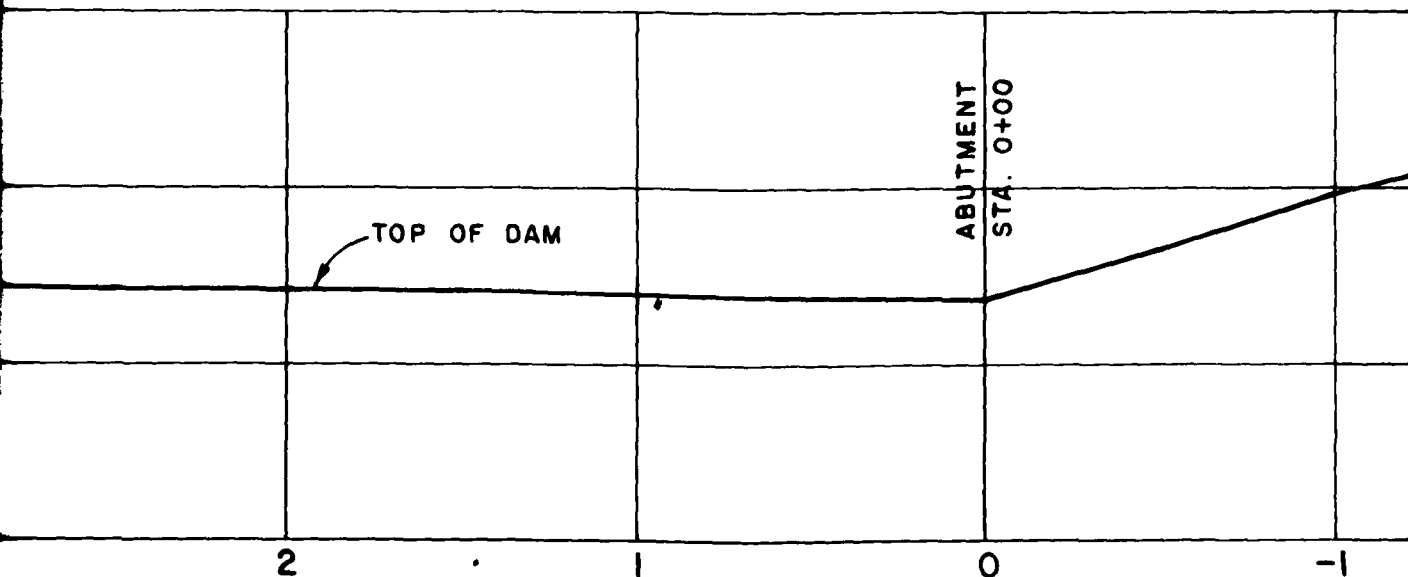
PLATE 3

and a downstream slope on the order of 1v on 3.1h. At the location of the original stream channel and at an elevation approximately 20 feet below the dam crest, the downstream slope flattens to about 1v on 5.2h. The length of the dam is approximately 462 feet. A plan and profile of the dam are shown on Plate 3 and a cross-section of the dam is shown on Plate 4. At normal pool elevation the reservoir impounded by the dam occupies approximately 7 acres. There is no drain line to dewater the lake.

a. General. A visual inspection of the Windy Knoll Lake Dam was made by Horner & Shifrin engineering personnel, R. E. Sauthoff, Civil Engineer, and A. B. Becker, Jr., Civil and Soils Engineer, on 9 June 1980. An examination of the dam area was also made by an engineering geologist, Jerry D. Higgins, Ph.D., a consultant retained by Horner & Shifrin for the purpose of assessing the site geology. Also examined at the time of the inspection, were the areas and features below the dam within the potential flood damage zone. Photographs of the dam taken at the time of the inspection are included on Pages A-1 through A-3 of Appendix A. The locations of the photographs taken during the inspection are indicated on Plate 3.
